4T65-AFL

A *Simple Drop in Repair* for a worn Actuator Feed Limit Bore.

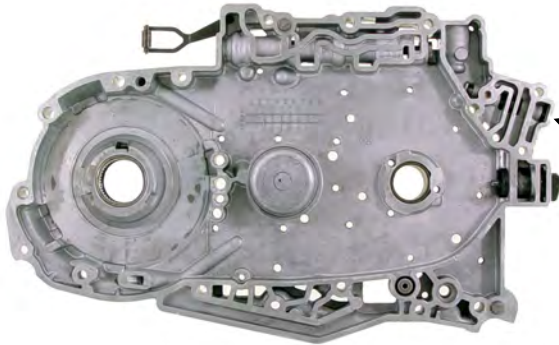
Step 1. Discard original AFL valve & spring, install New Bushing, Valve, Orange spring & spacer. Reuse the original retainer.

New Bushing may be a little tight going in, due to wear ridge. Use either end of the old valve to push the new bushing into place if necessary. The new bushing never moves in the bore once installed so its ok to be tight.

Discard original AFL valve & spring
