# **Installation Instructions**

# 2022 Subaru BRZ / Toyota GR86 Axle Back Exhaust

Part No. 91Z153 & 91Z154

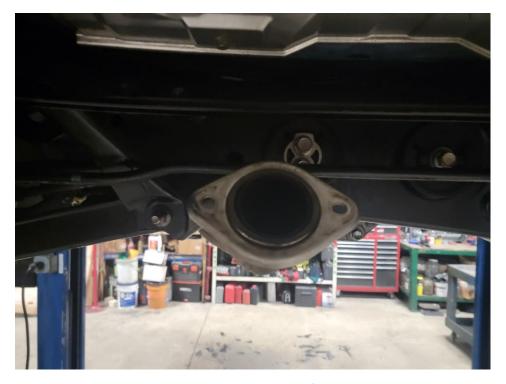
## Removing the factory exhaust system:

**STEP #1:** Remove the two bolts holding the stock axle back to the rest of the exhaust.

**Step #2:** Remove the four hangers on the stock exhaust from the rubber hang points.

**Step #3:** Remove stock system from the vehicle.

**Step #4:** Keep the factory gasket as it will be used to install the new system.

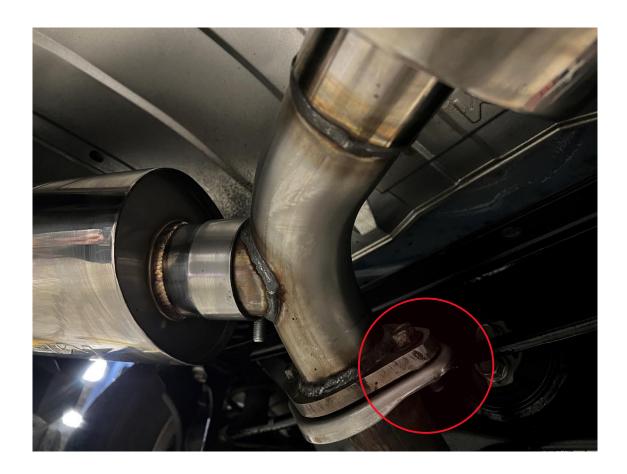
Step #1 Place passenger side axle back tube onto the passenger side rubber hang point.

Step #2 Bolt the passenger side exit to the vehicles under axle tube using the provided bolts, spacers and lock washers. The spacers will fit between the two flanges. The OEM gasket will be reused.

**Bolt>MRT Flange>Spacer>Stock Flange>Washer>Lock Nut**
